TAMU Project

**Energy Consumption Data Quality Assurance/Quality
Control Assessment Report for the
Month of November 2017**

**Utility & Energy Services
Division of Administration
Texas A&M University**

December 2017

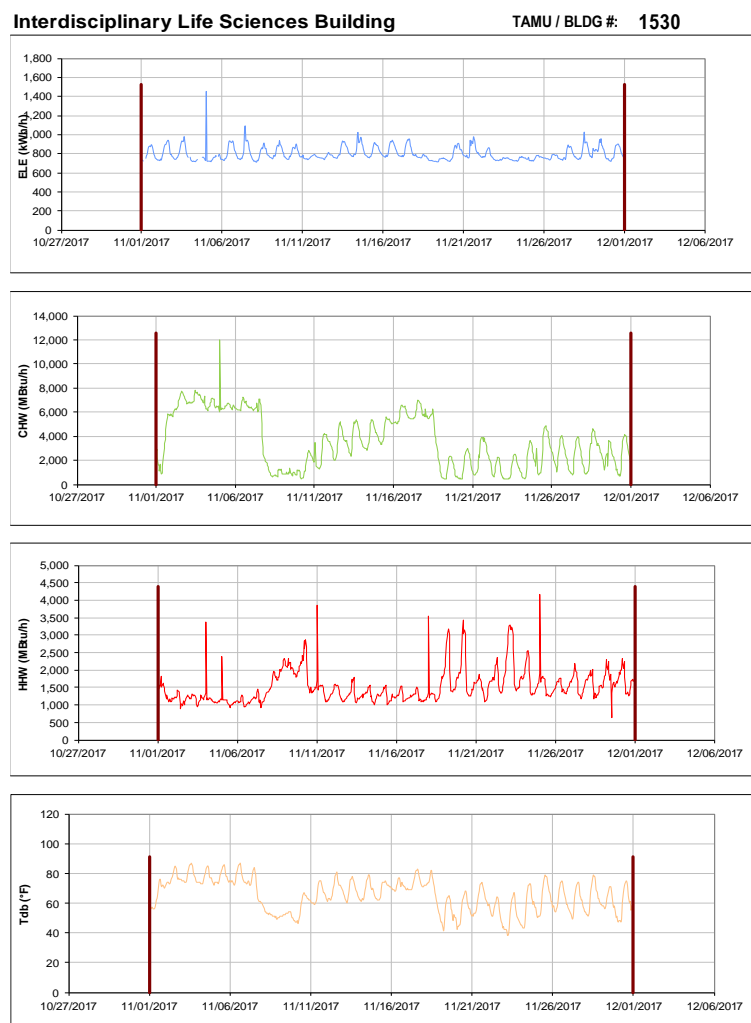
Figure III-171 Hourly Whole Building Electricity, Chilled Water, and Hot Water Consumption for Interdisciplinary Life Sciences Building during the Month of November 2017 and the Corresponding Hourly Outdoor Dry Bulb Temperature for College Station, TX

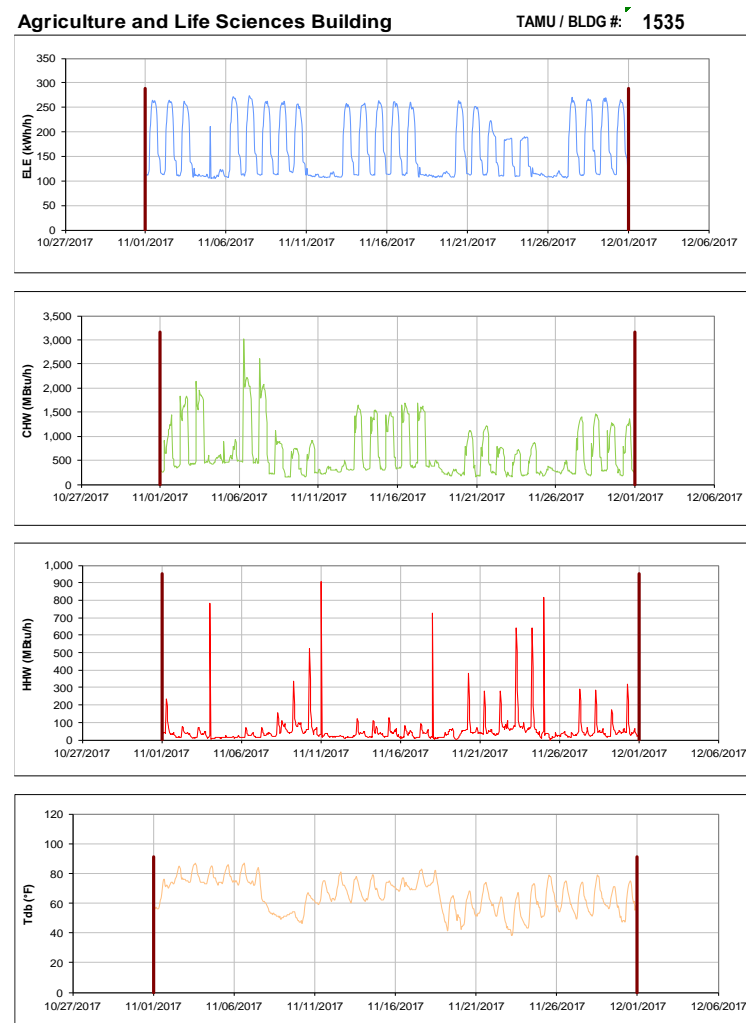
Figure III-172 Hourly Whole Building Electricity, Chilled Water, and Hot Water Consumption for Agriculture and Life Sciences Building during the Month of November 2017 and the Corresponding Hourly Outdoor Dry Bulb Temperature for College Station, TX

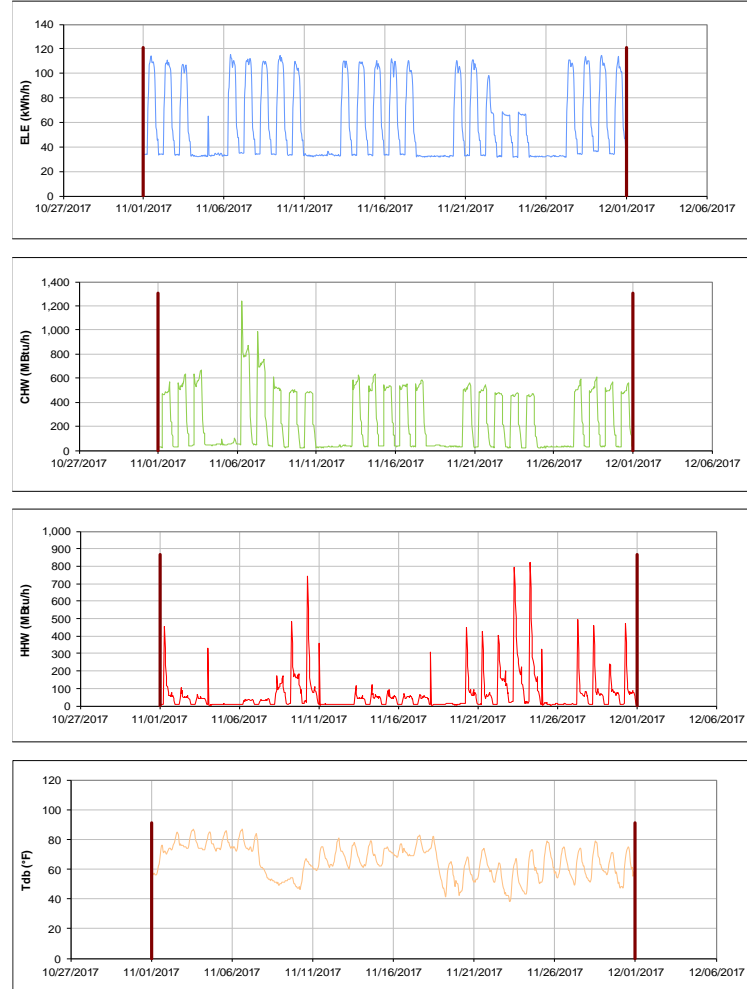
TAMU / BLDG #: 1536

Figure III-173 Hourly Whole Building Electricity, Chilled Water, and Hot Water Consumption for AgriLife Services Building during the Month of November 2017 and the Corresponding Hourly Outdoor Dry Bulb Temperature for College Station, TX

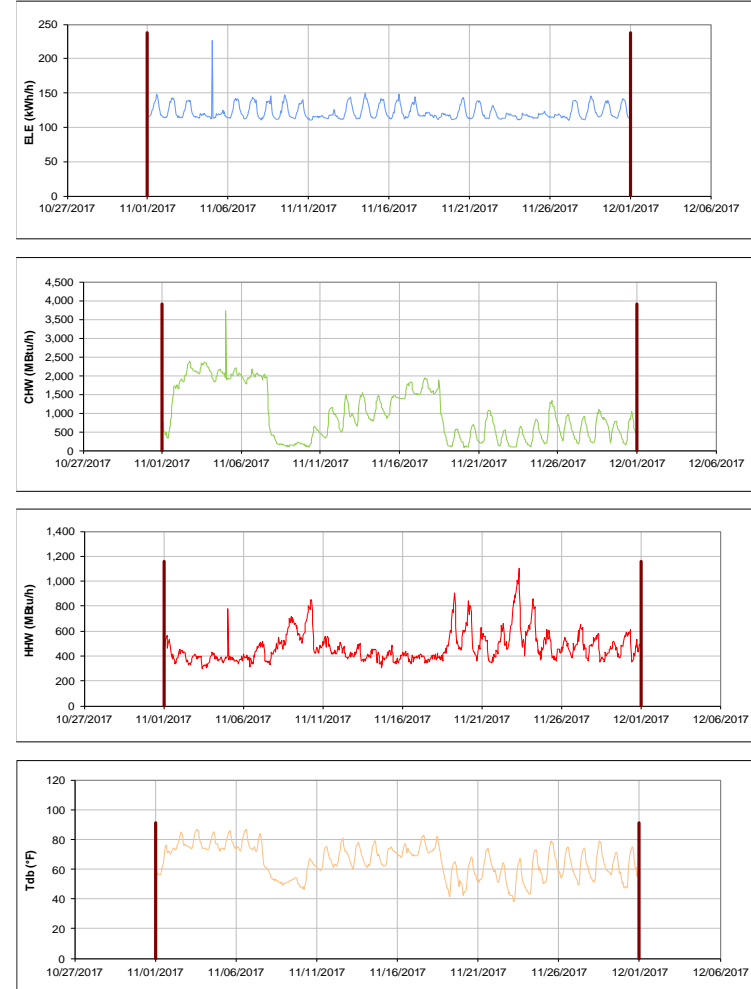
TAMU / BLDG #: 1537

Figure III-174 Hourly Whole Building Electricity, Chilled Water, and Hot Water Consumption for Wildlife Fisheries & Ecological Sciences Building during the Month of November 2017 and the Corresponding Hourly Outdoor Dry Bulb Temperature for College Station, TX

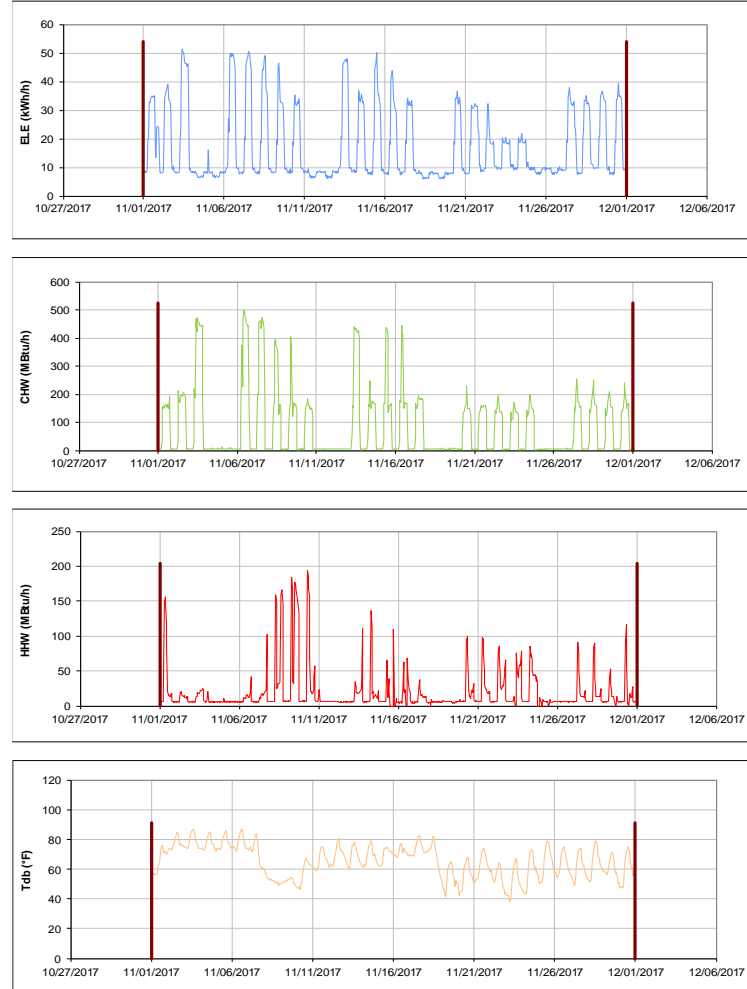
TAMU / BLDG #: 1538

Figure III-175 Hourly Whole Building Electricity, Chilled Water, and Hot Water Consumption for Agriculture Program Visitors Center during the Month of November 2017 and the Corresponding Hourly Outdoor Dry Bulb Temperature for College Station, TX

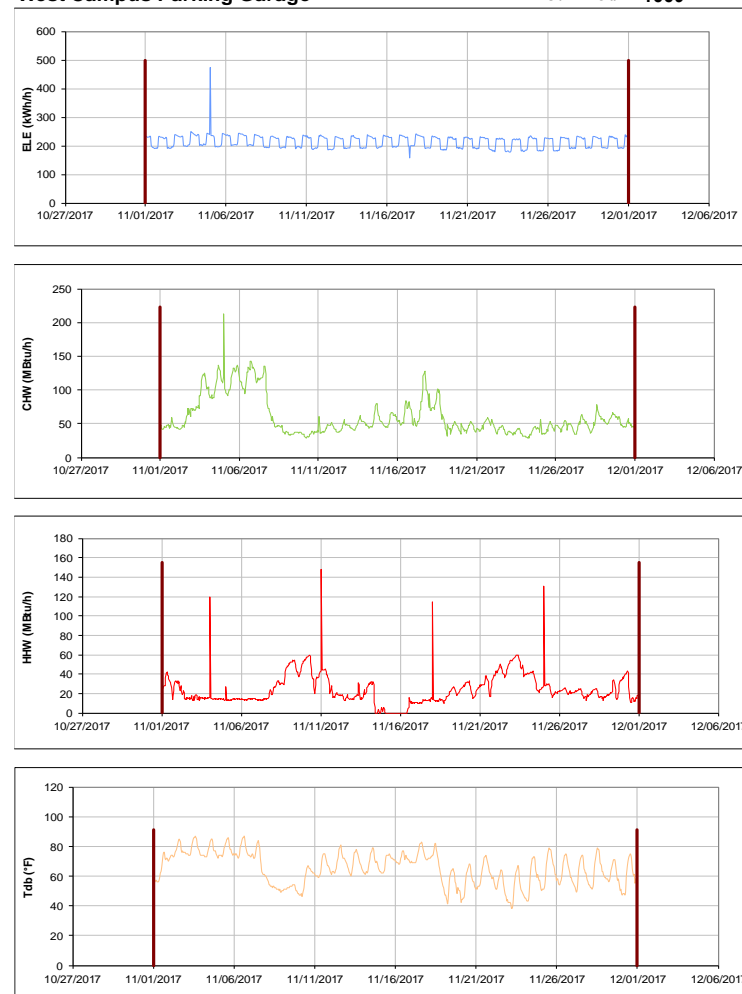
TAMU / BLDG #: 1559

Figure III-182 Hourly Whole Building Electricity, Chilled Water, and Hot Water Consumption for West Campus Parking Garage during the Month of November 2017 and the Corresponding Hourly Outdoor Dry Bulb Temperature for College Station, TX

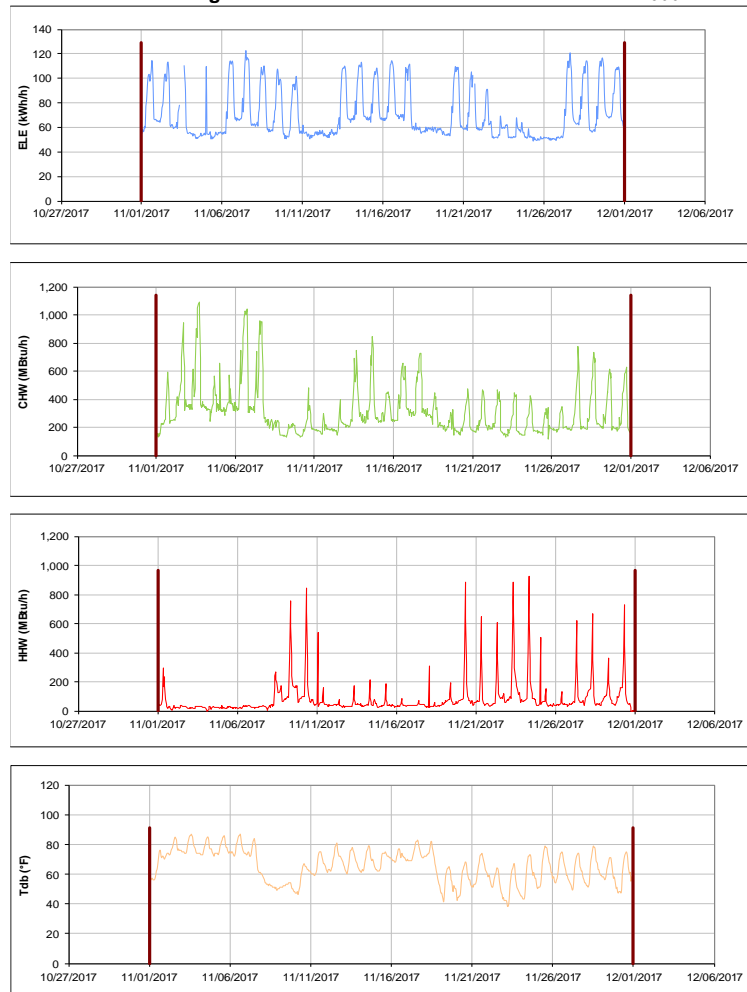
TAMU / BLDG #: 1600

Figure III-187 Hourly Whole Building Electricity, Chilled Water, and Hot Water Consumption for Gilchrist TTI Building during the Month of November 2017 and the Corresponding Hourly Outdoor Dry Bulb Temperature for College Station, TX

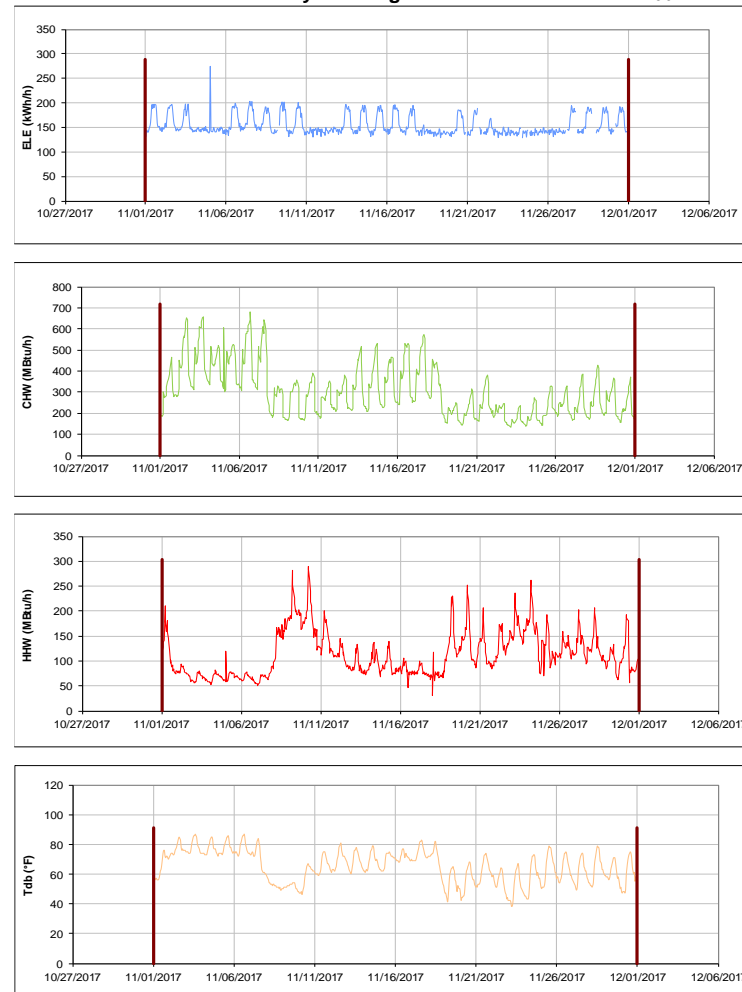
TAMU / BLDG #: 1601

Figure III-188 Hourly Whole Building Electricity, Chilled Water, and Hot Water Consumption for International Ocean Discovery Building during the Month of November 2017 and the Corresponding Hourly Outdoor Dry Bulb Temperature for College Station, TX

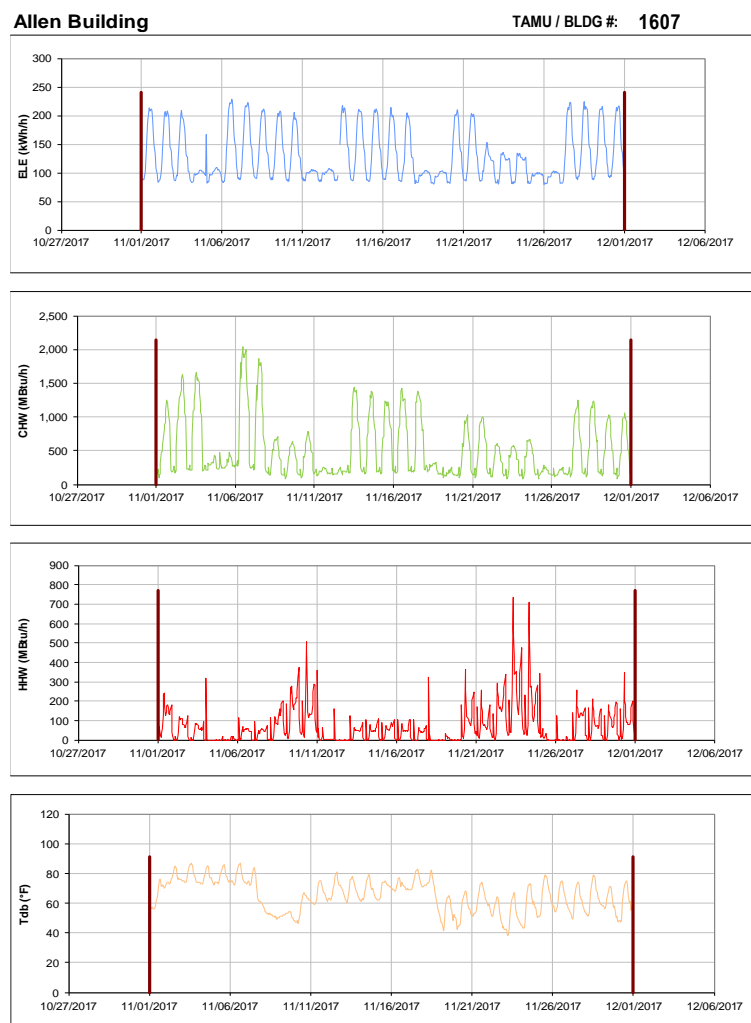
Figure III-191 Hourly Whole Building Electricity, Chilled Water, and Hot Water Consumption for Allen Building during the Month of November 2017 and the Corresponding Hourly Outdoor Dry Bulb Temperature for College Station, TX

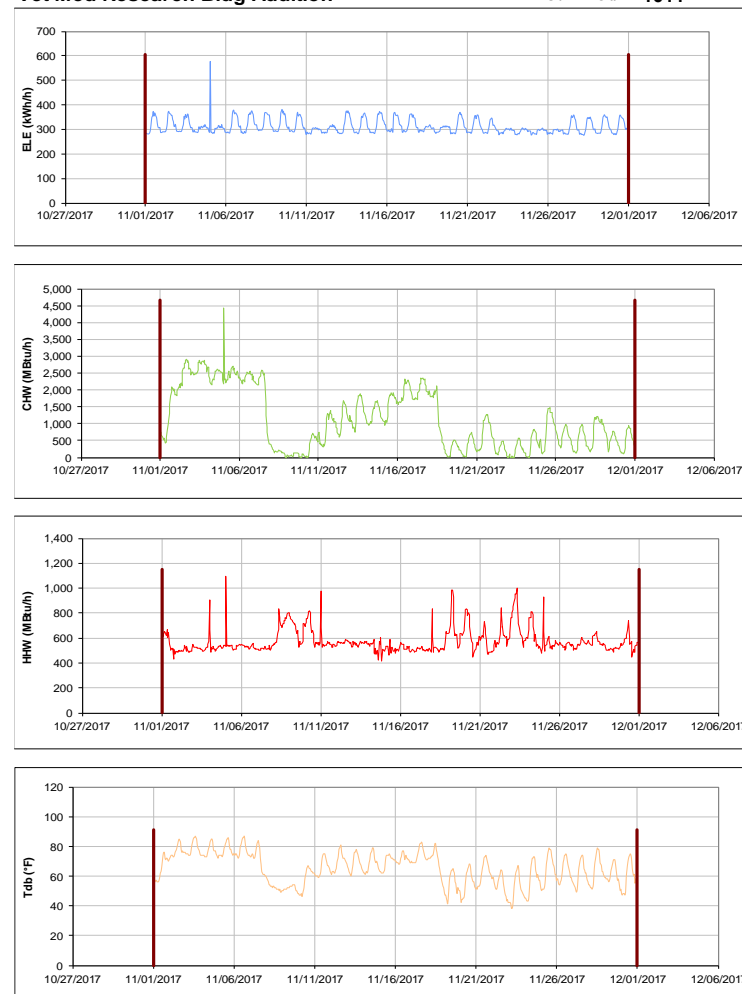
TAMU / BLDG #: 1811

Figure III-198 Hourly Whole Building Electricity, Chilled Water, and Hot Water Consumption for Vet Med Research Bldg Addition during the Month of November 2017 and the Corresponding Hourly Outdoor Dry Bulb Temperature for College Station, TX

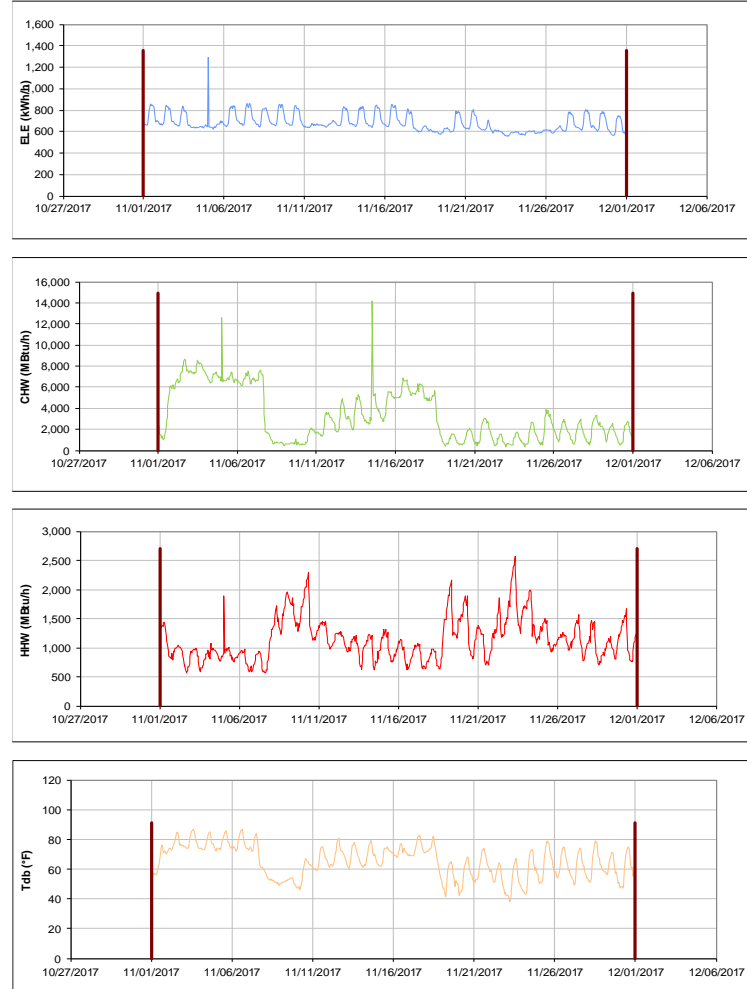
TAMU / BLDG #: 2-1813-1814

Figure III-199 Hourly Whole Building Electricity, Chilled Water, and Hot Water Consumption for Veterinary Medicine Building 1, 2, and 3 during the Month of November 2017 and the Corresponding Hourly Outdoor Dry Bulb Temperature for College Station, TX

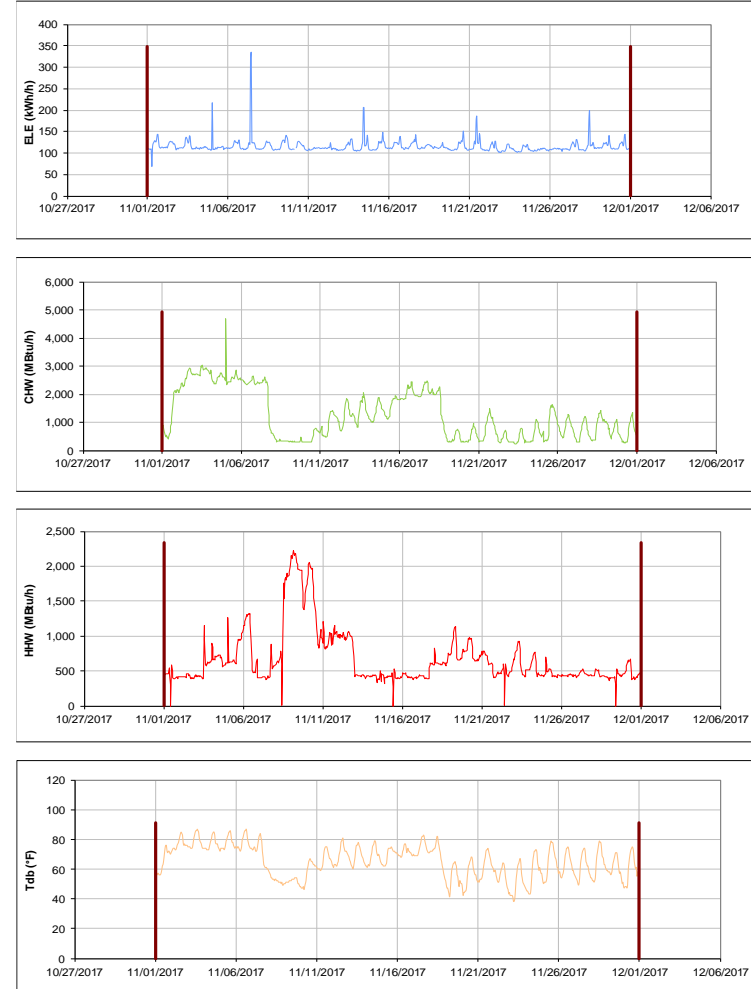
TAMU / BLDG #: 1900

Figure III-200 Hourly Whole Building Electricity, Chilled Water, and Hot Water Consumption for Texas Institute for Genomic Medicine during the Month of November 2017 and the Corresponding Hourly Outdoor Dry Bulb Temperature for College Station, TX
